# PROPERTY INTELLIGENCE REPORT

## Subject Parcel 14908 - 0 Mills Rd

Pitt County, North Carolina

| REPORT TYPE | Demonstration / Screening-Level GIS Review |

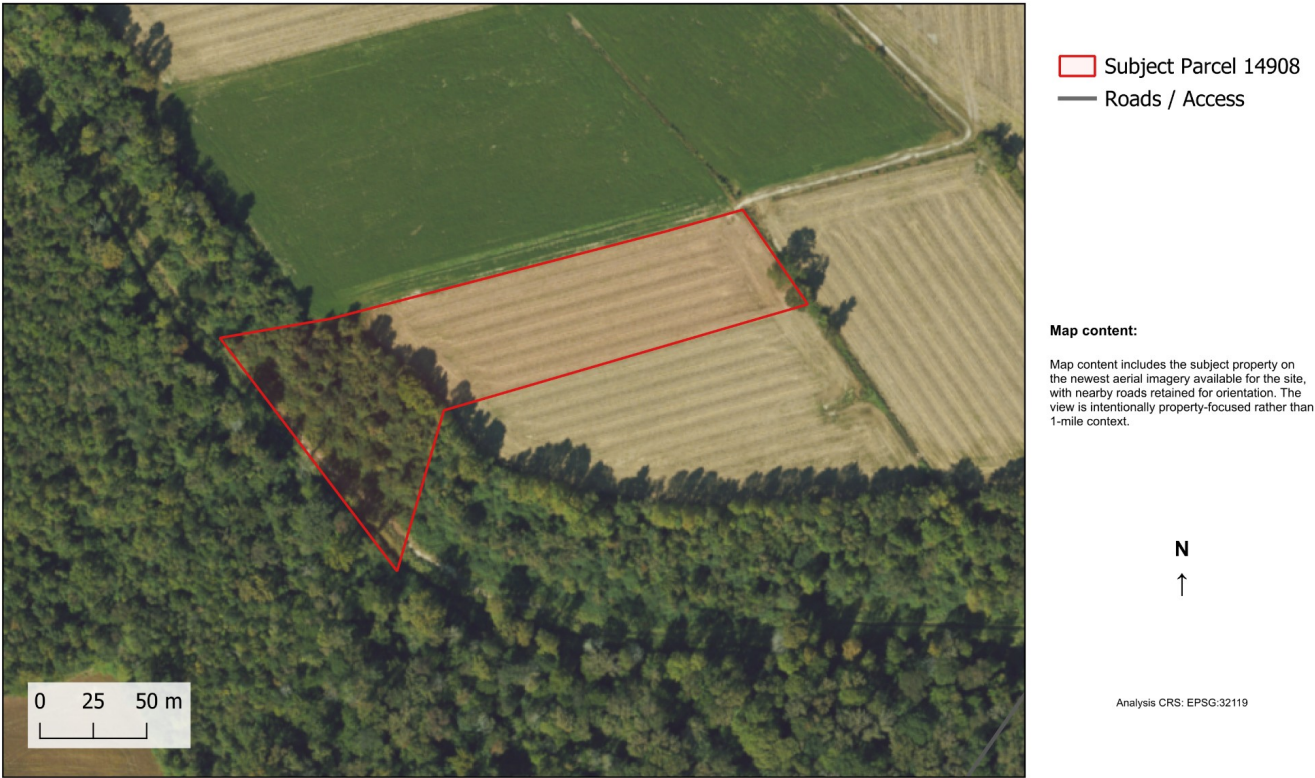
Figure 1. Latest available aerial imagery used for the subject parcel screening (2022).

**Observation:** The subject parcel appears predominantly open/cultivated with wooded cover along the western and southern portions/edges. No obvious building development is visible within the subject boundary in this image.

**Use of this map:** The imagery provides a visual baseline only. It does not confirm legal land use, boundary location, utilities, septic suitability, or environmental conditions.

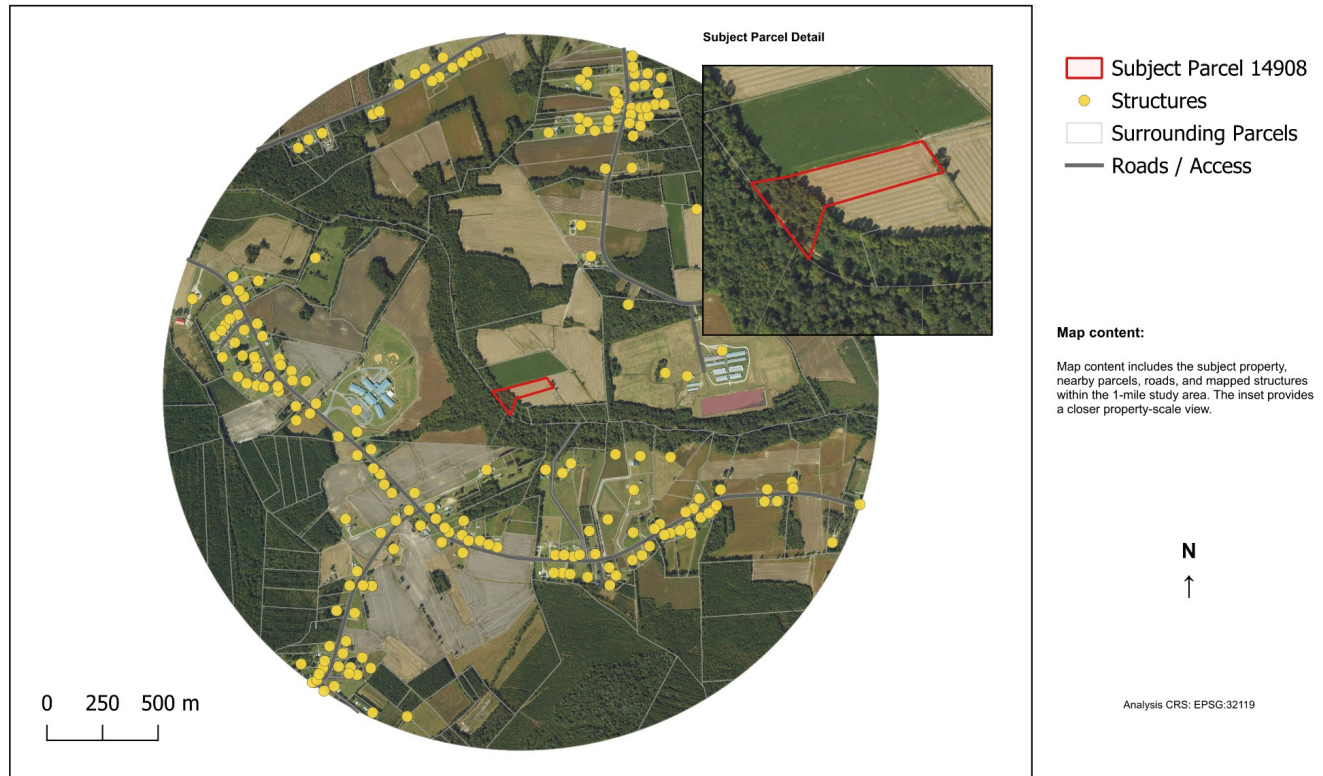
Figure 2. Subject parcel, surrounding parcels, mapped structure points, roads/access, and close-up parcel inset.

- Mapped structures are concentrated along surrounding roads and developed properties within the 1-mile study area.
- The subject parcel itself does not show mapped structure points in the displayed structure layer.
- The inset confirms the subject parcel remains visually dominated by open/cultivated and wooded land rather than established building development.

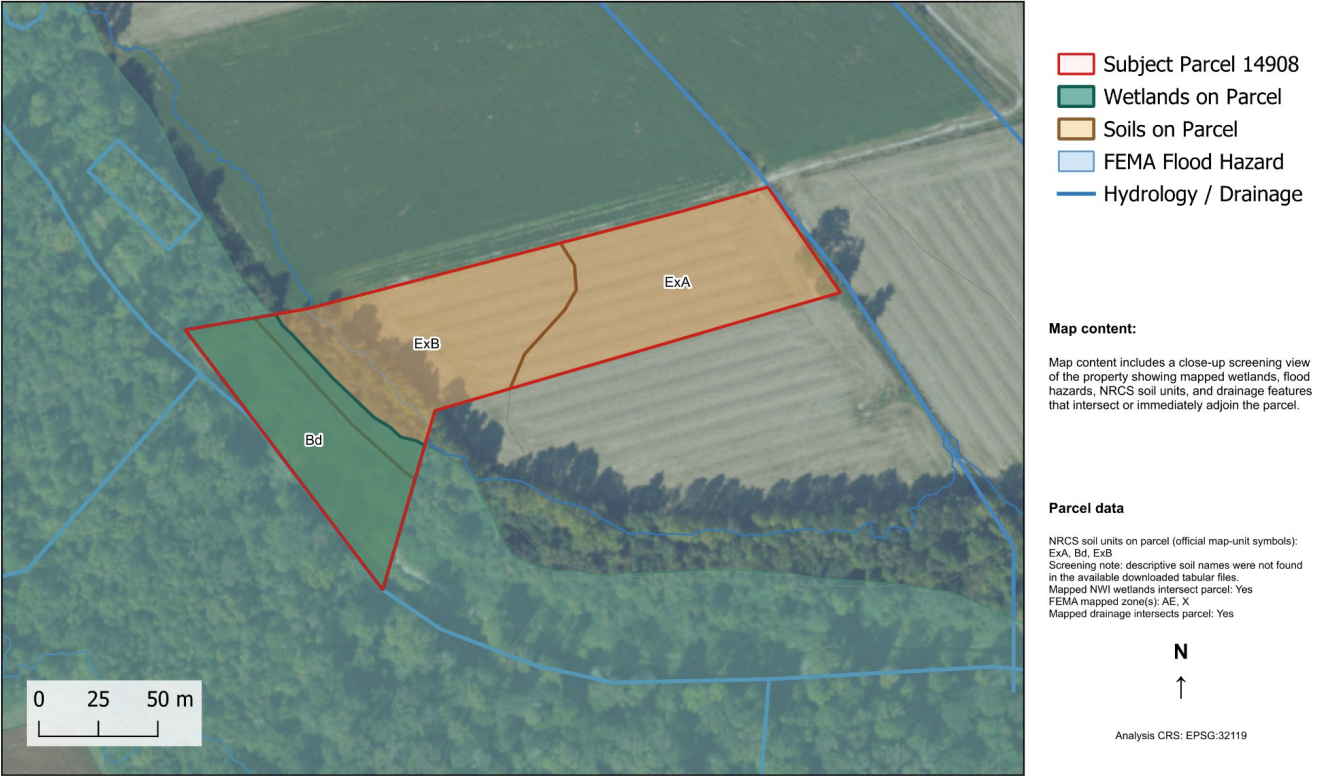
Figure 5. Close-up parcel screening showing mapped wetlands, FEMA flood hazard, NRCS soil map units, and drainage.

| Screening item | Mapped result |
| NRCS soil symbols | ExA, ExB, Bd |
| Mapped NWI wetlands | Intersect subject parcel: Yes |
| FEMA zones on parcel | AE and X |
| Mapped drainage | Intersects subject parcel: Yes |

**Interpretation:** These are screening flags, not final jurisdictional or engineering determinations. The mapped overlap is sufficient to justify closer wetland, flood/elevation, drainage, and soil/septic review before development decisions.

Because mapped NWI wetlands intersect the parcel, confirm whether proposed use would affect mapped wet areas. A jurisdictional determination or professional wetland delineation may be appropriate for development planning.

Confirm FEMA mapping and site elevations through authoritative flood information, survey/elevation work, and engineering review when structures or fill are proposed in or near mapped flood-prone areas.

Use the full NRCS soil survey and local health/environmental requirements to evaluate septic suitability and other soil limitations. Map-unit symbols alone are not a site-specific suitability test.

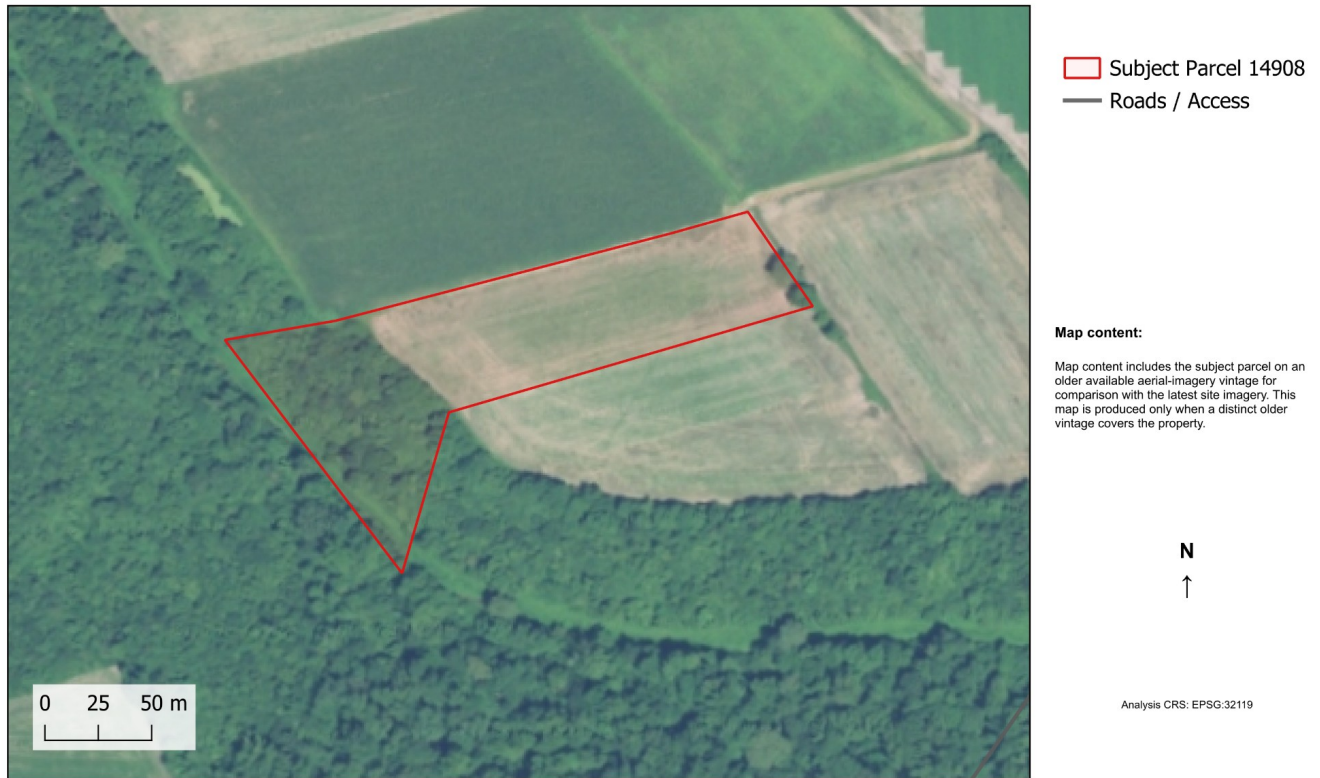
Figure 9. Historical aerial imagery (2016) with the subject parcel boundary.

- The 2016 image shows the subject parcel in a broadly similar agricultural/open and wooded setting to the 2022 image.
- No obvious building development on the subject parcel is apparent in the two imagery vintages presented in this report.
- This comparison uses two available image dates only and is not a complete historical land-use investigation.
